Welcome to my page on the complete strip down of the

Tamiya 3 speed 4 wheel drive transmission

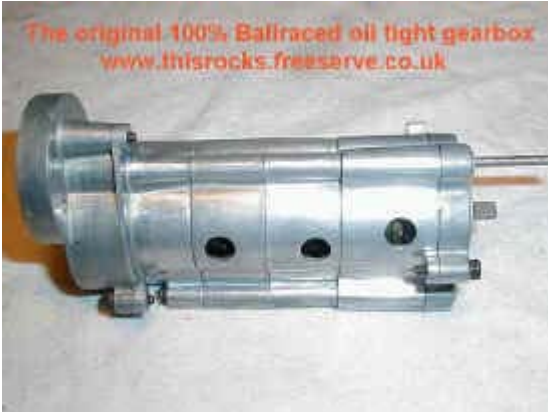
So I begin, this transmission is of the brass gear type, Some gearboxes have more aluminium gears in them.

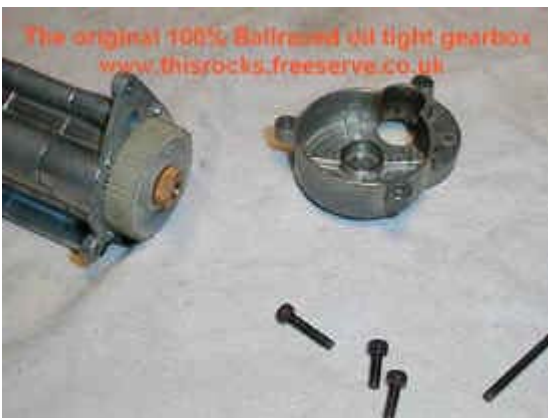
So we begin by removing the front case, Check the spur for wear. The pinion is very small on the motor and has a high wear rate.

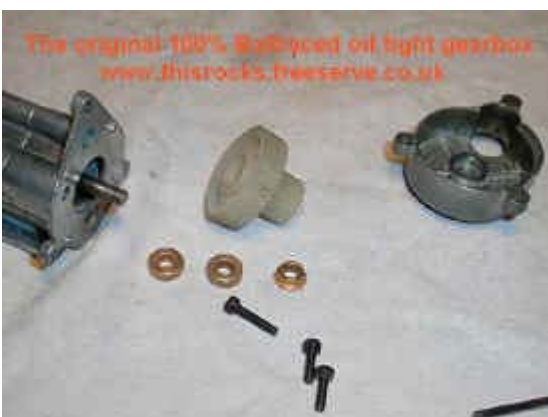
Pull of the spur gear and examine the input shaft for wear.

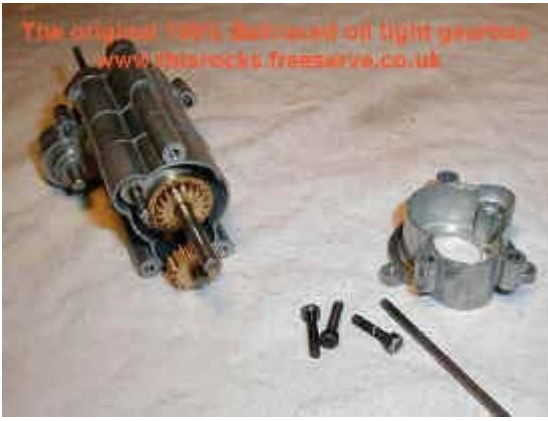
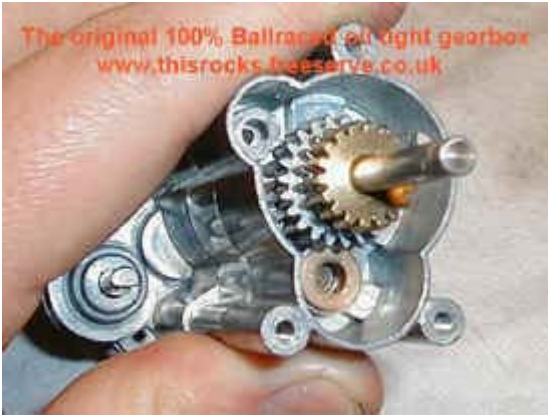
Removing the next casing shows the 2nd / 3rd gear dog ring. Some people call them syncro rings. Pull of the selector fork and the dog ring. Under the input shaft you will find the 2nd gear lay shaft this also just pulls out.

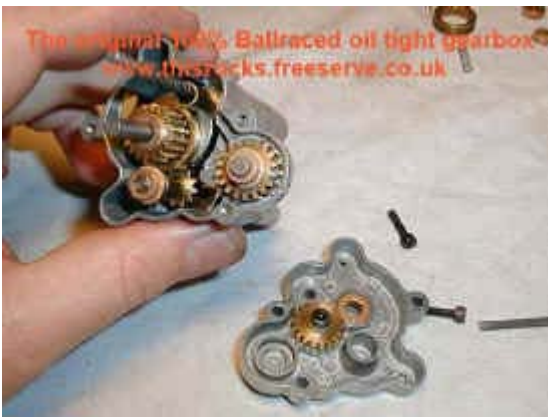
This shows the contents of the above removed.

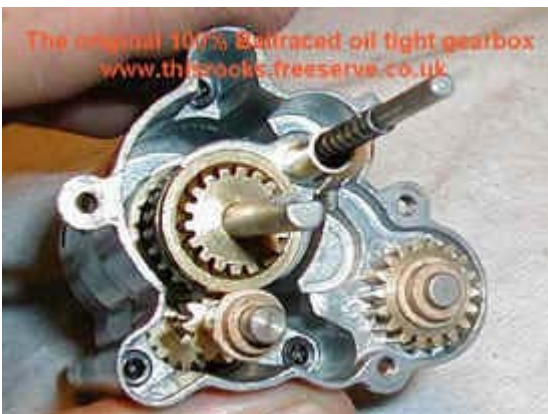
Now we move to the end of the gearbox.
This shows the casing removed.

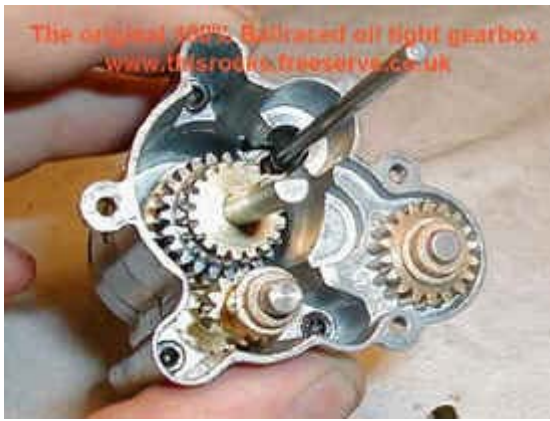
This end of the gearbox is a little more technical,
It has both the 1st gear dog ring and also the 4 wheel drive
dog ring.
Here you can see the output shaft in the centre.
Below the 1st gear lay shaft.
To the right you see the 4 wheel drive output shaft.
The top dog ring is the 4 wheel drive.
The lower is the 1st gear ring.

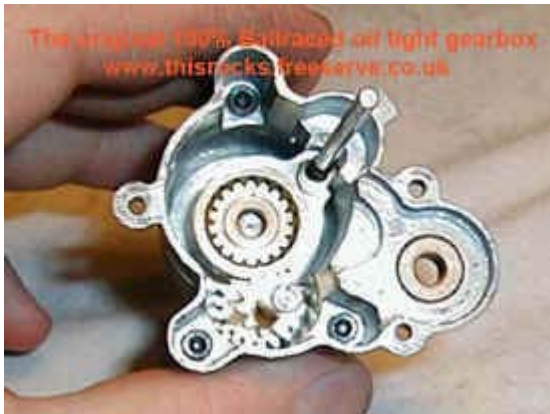
As before remove the top dog ring and its selector fork.
Just pull out the 4 wheel drive output shaft.

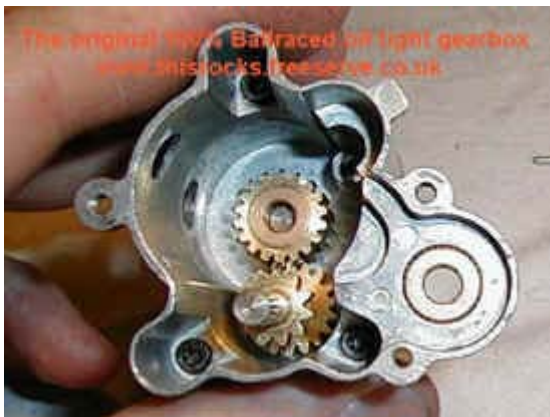
Here you see the above removed

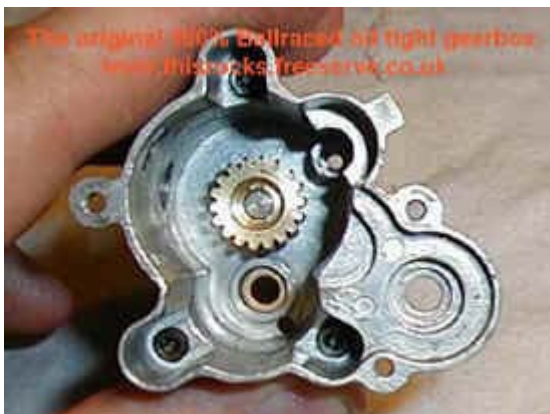
Now remove the 1st gear dog ring and the selector fork
complete with the selector shaft.
Also remove the bearing and spacer on the lay shaft.

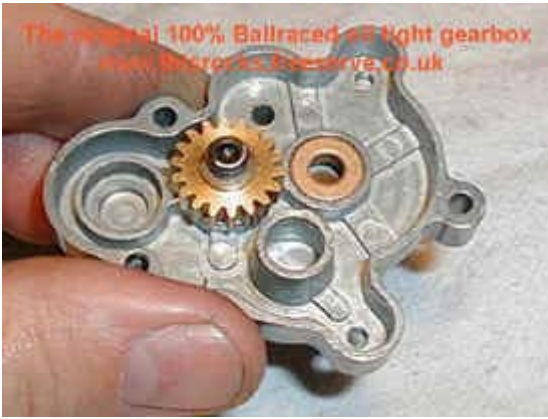
As before the contents removed.
Here you see the back of the input shaft.
Now without pressing out the input shaft this cannot be removed.
Pressing out this shaft can be done with special equipment.
This is done very carefully not to brake the casing or deform
the gears.
More later in this write up

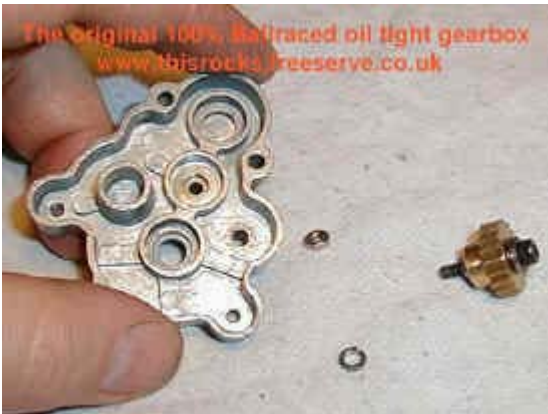
The rear casing showing the 4 wheel drive idler gear

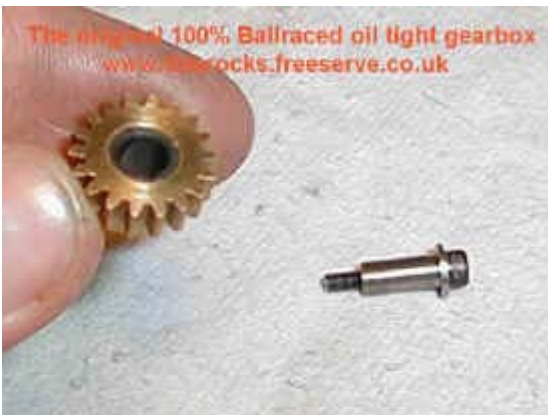
Remove the idler gear

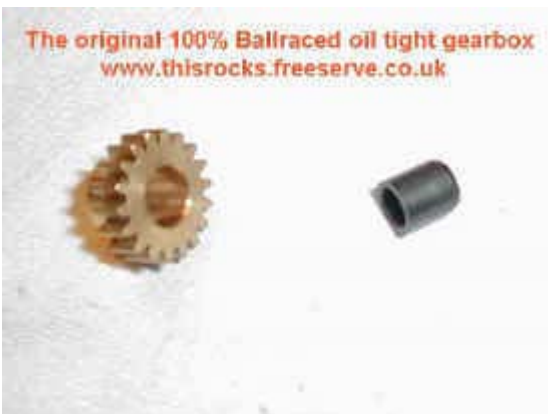
A very crude bush lives in here,
Not very good thinking how much torque goes through this.

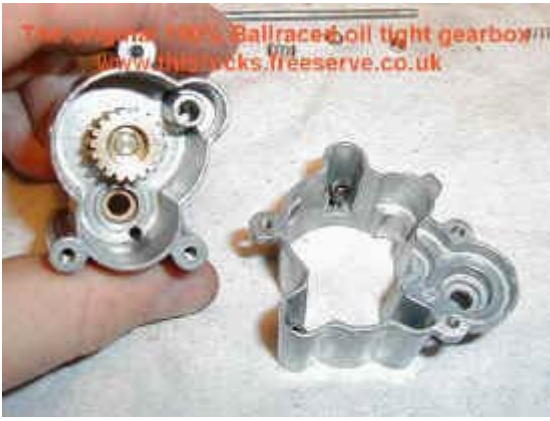
The idler with the bush pressed out

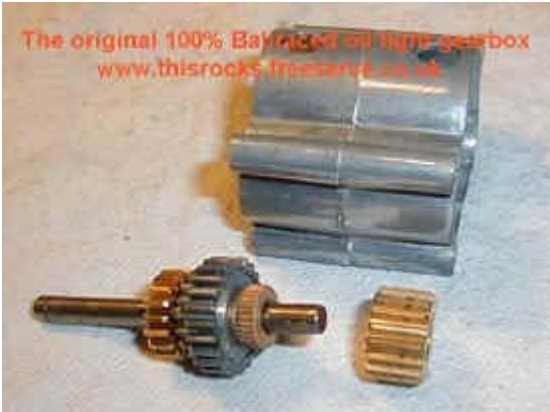
The last casing you can remove

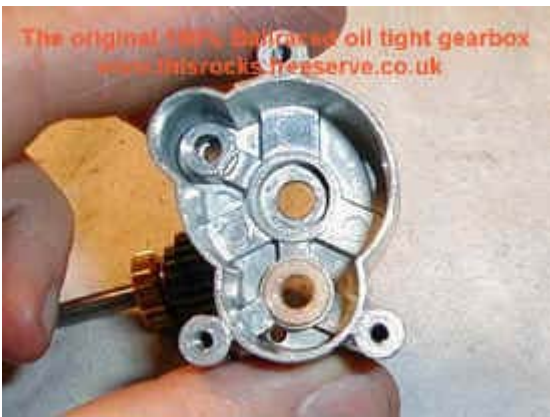
Back to our input shaft.
This shows the input shaft once it has been pressed out.
This is some of the bearings that can not be removed without special equipment.
Once removed it needs to be machined to be reassembled.

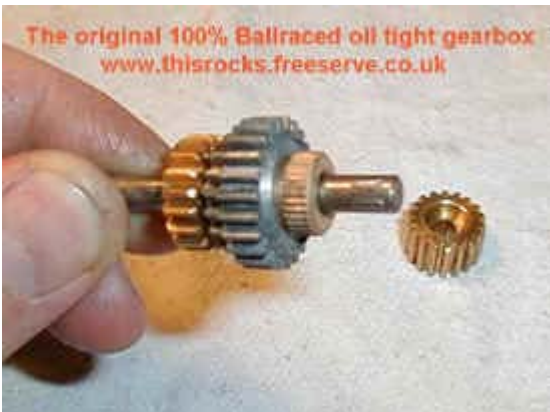
The centre casing with the input shaft removed.
viewed from the front.
You now can remove the 2nd gear lay shaft bearing.

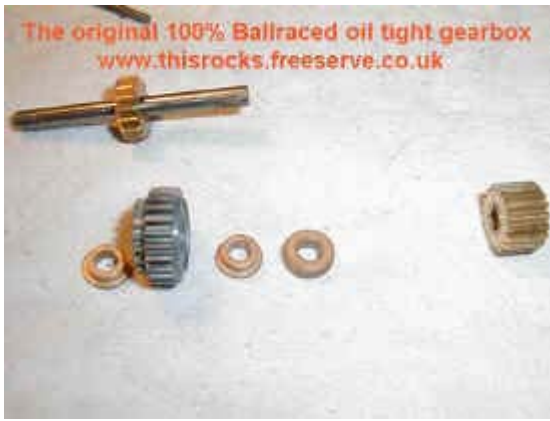
This bearing here takes all the load of the input and output shafts in the centre.
This bearing gets a lot of wear.

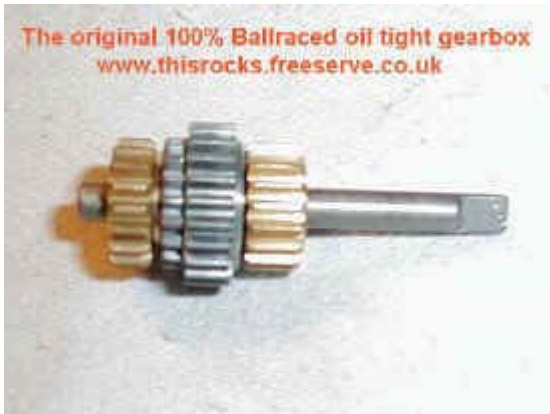
There are more bearings on this shaft in the 2nd gear. These bearings can not be removed without machining. Once removed it needs to be machined to be reassembled.

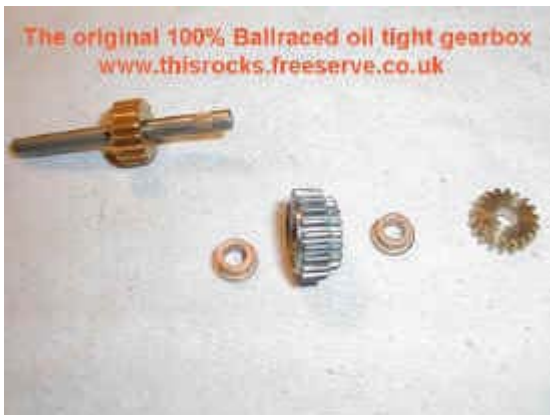
Now we return to the output shaft This has the 4 wheel drive gear on it. Once again this gear assembly has to be pressed apart. Using special equipment this can be removed.

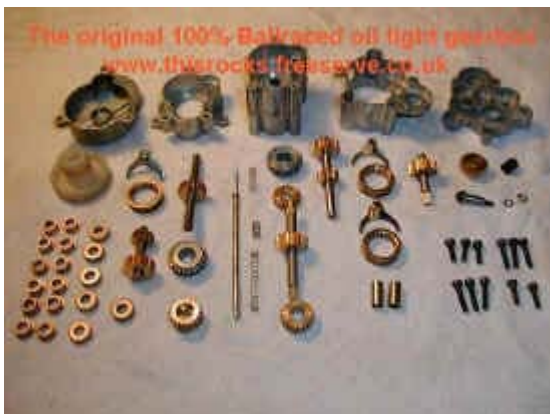
Once pressed apart the shaft needs to be machined to remove the gear and bearings. As with the input shaft is needs machined to be reassembled.
